# Arlebury Park

The Avenue  
Alresford  
Hampshire  
SO24 9EP

ASBESTOS MANAGEMENT REVIEW  
AND  
ANNUAL REGISTER UPDATE

March 2023

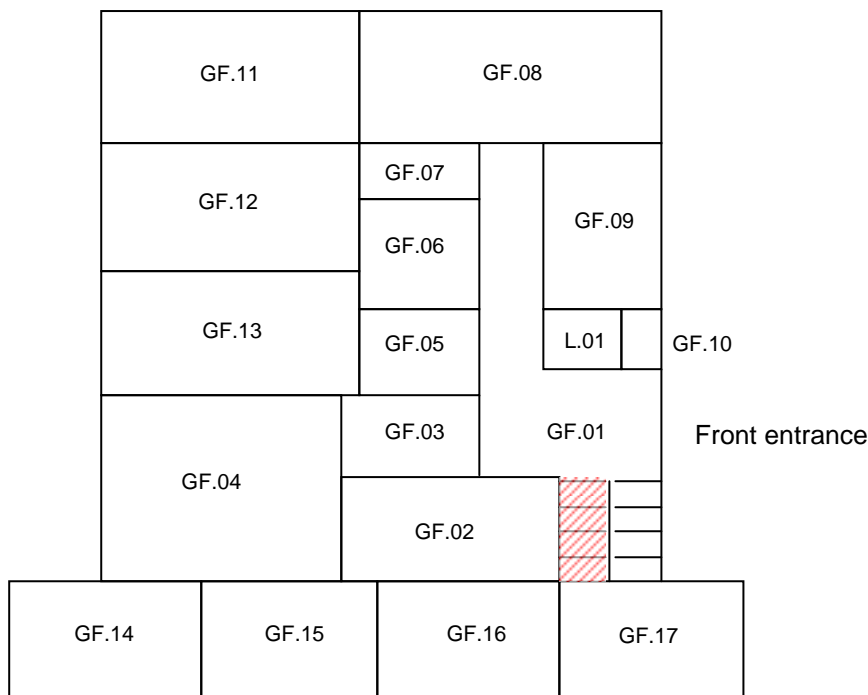
**Figure 1** Plan showing ground floor areas of the main building

The areas where asbestos-containing materials (ACMs) have been detected have been shown by means of red shading. In the main building (ground floor and first floor) this refers to areas where the ceilings have a textured coating containing asbestos, whereas in the outbuilding this refers to cement-bonded asbestos undercloaking at the gable edge of the roof (front and back).

With regards to the asbestos-containing textured coatings to the cellar ceiling and stair wall on the ground floor of the main building, the latter is particularly vulnerable; being at body level for anyone using the stairs. Furthermore there are small signs of damage appearing here, presumably from scuffing.

This section of the wall needs to have greater protection by means of encapsulation at least. Once again this needs to be labelled as well.

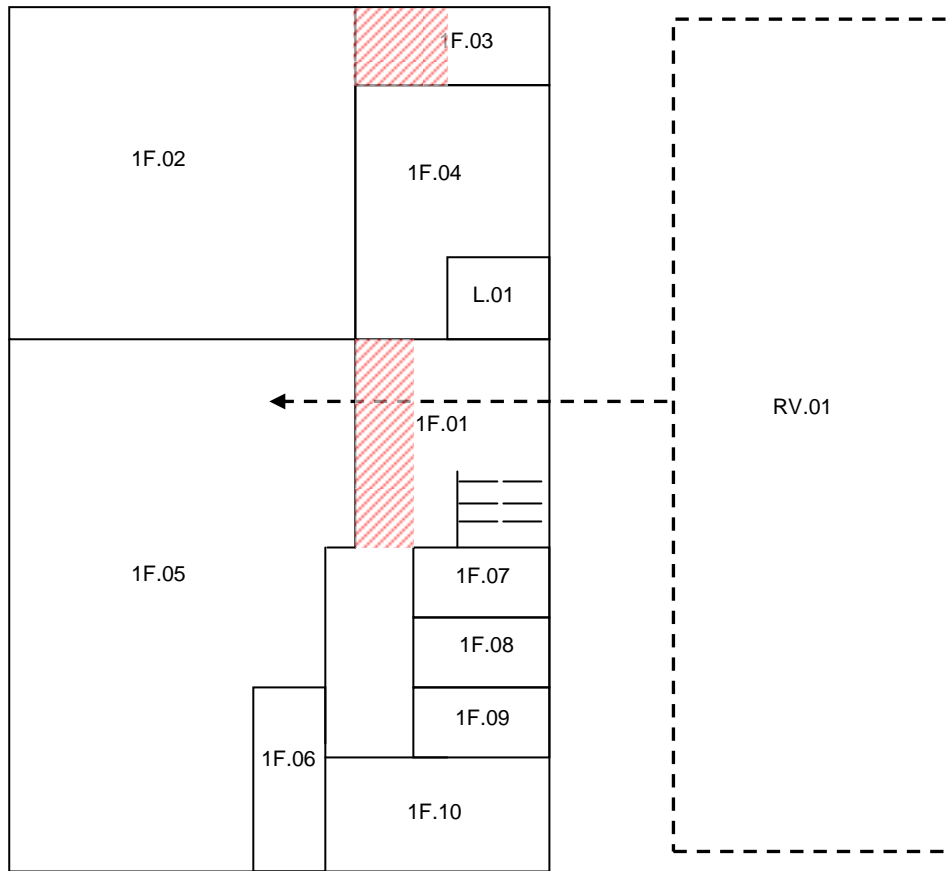
**Figure 2** Plan showing first floor areas of the main building

Secondly, the front sections of the first floor landing and first floor kitchen ceilings no longer have a textured coating. It is not known whether these are entirely new ceiling sections or whether the original coatings have been skimmed with plaster. It is understood that these ceilings became damaged during the recent replacement of the roof.

The presumption must be made that there could still be some of the original textured coating beneath the finishing plaster, and therefore this has been noted on the premises asbestos register.

With regards to the remaining sections of ceiling within these two room areas, these have been repainted in order to provide some degree of protection from accidental damage or natural deterioration; although these still require appropriate labelling.

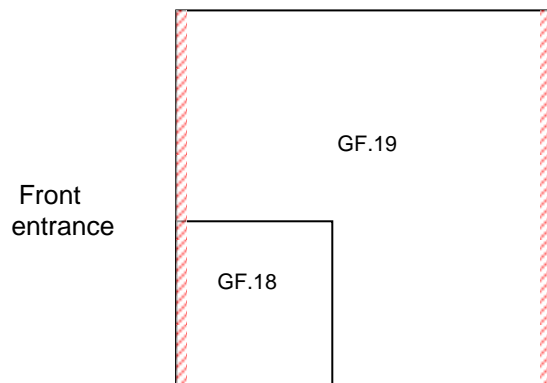
**Figure 3** Plan showing the football garage outbuilding

Football garage EXTERIOR	S.14	Cement panel undercloaking to gable roof edges contains asbestos	1	2	1	0	1	1	0	1	0	0	0	0	7	Maintain in good order and inspect yearly 08.03.2024
